DRAFT - HOT SPRINGS BLVD URA CONDITIONS SURVEY - DRAFT

2.0 SURVEY RESULTS

This Conditions Survey was conducted in the area (the "Survey Area") described in Exhibit A and depicted in Exhibit B, both of which are attached to and made a part of this Conditions Survey. The Survey Area includes approximately 11 separate parcels of land covering approximately 45 acres and the adjoining Hot Springs Boulevard right of way from its intersection with US Highway 160 to Apache Street.

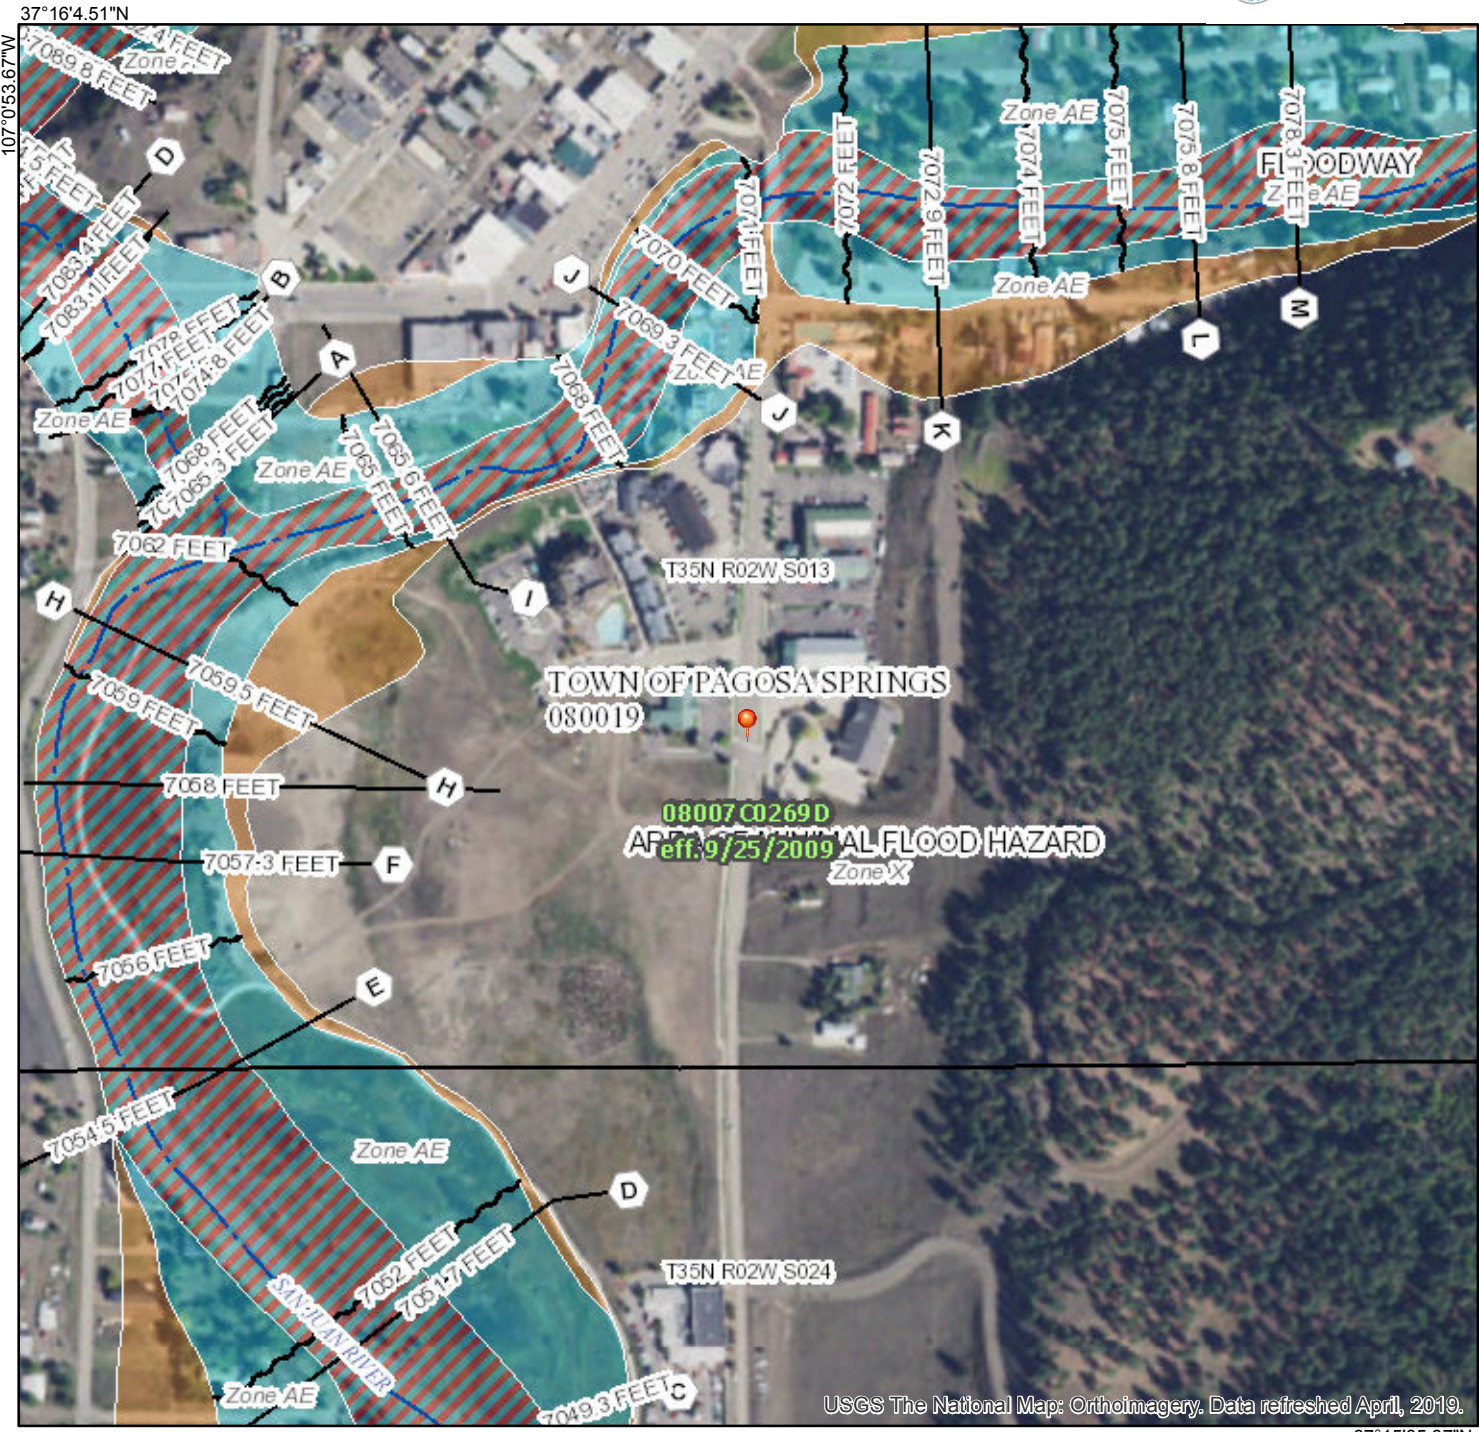
EXHIBIT C
FEMA Flood Map

As shown on Exhibit C, the northerly and westerly borders of the Survey Area are in the 100-year flood plain and floodway area. Such areas are designated by FEMA as Areas of Special Flood Hazard. These problems in the Survey Area qualify as an unsafe condition under the Act. Exhibit D shows the location of natural hot springs that emit scalding water. Also present in the Survey Area is evidence of voids / caverns beneath the ground surface of the open land area. There is evidence of materials dumping in parts of the Survey Area. There is no public lighting in much of the area. These conditions constitute both unsanitary and unsafe conditions in the Survey Area.
